National Park Service
Cultural Landscapes Inventory
2001

Thurmond Historic District
New River Gorge National River

**Cultural Landscapes Inventory
Condition Reassessment
2010**

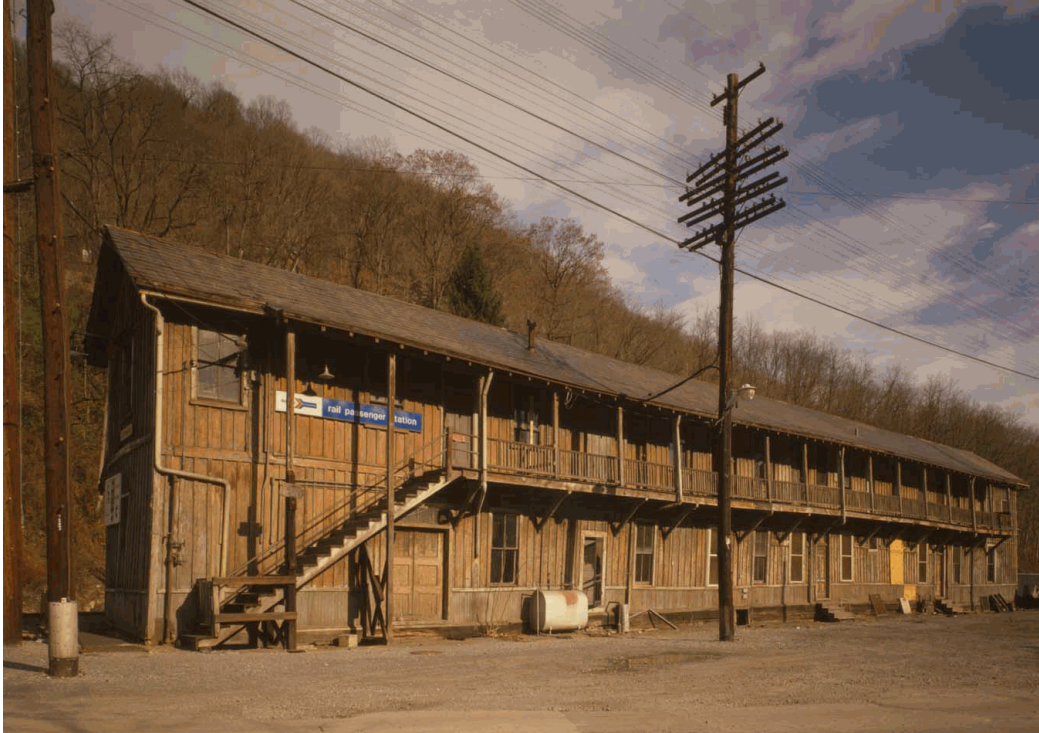
Thurmond passenger depot in 1988, before rehabilitation (HAER WV 42A-8(CT)).

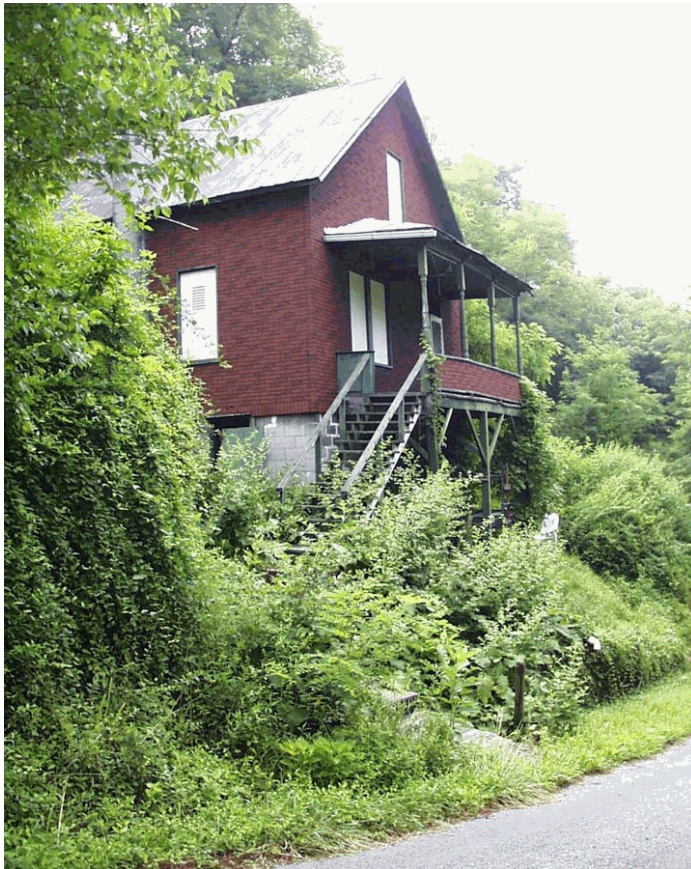
Typical mid-summer vegetation growth in district, vacant Wedzel Young House (PHSO 2002).

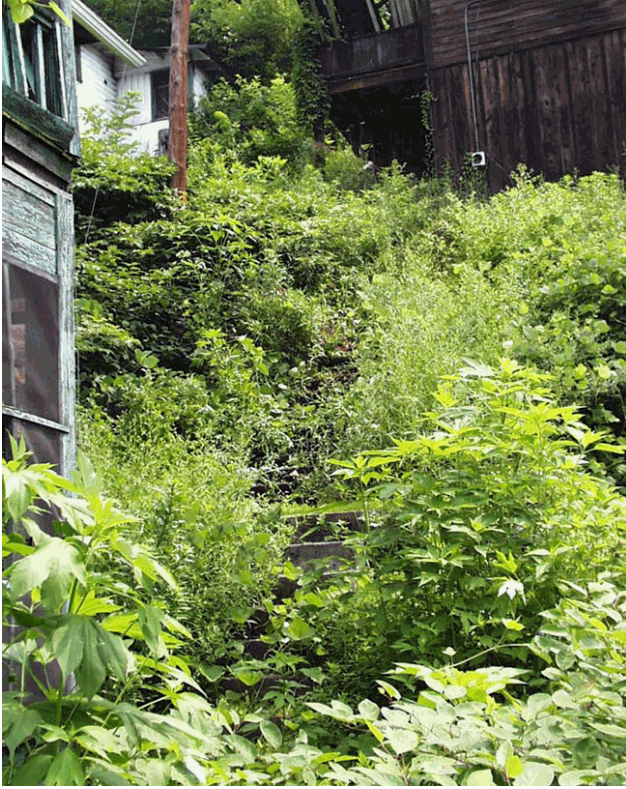
Landscape feature of steps obscured by vegetation, Sid Childers/Margie Richmond House (PHSO 2002).

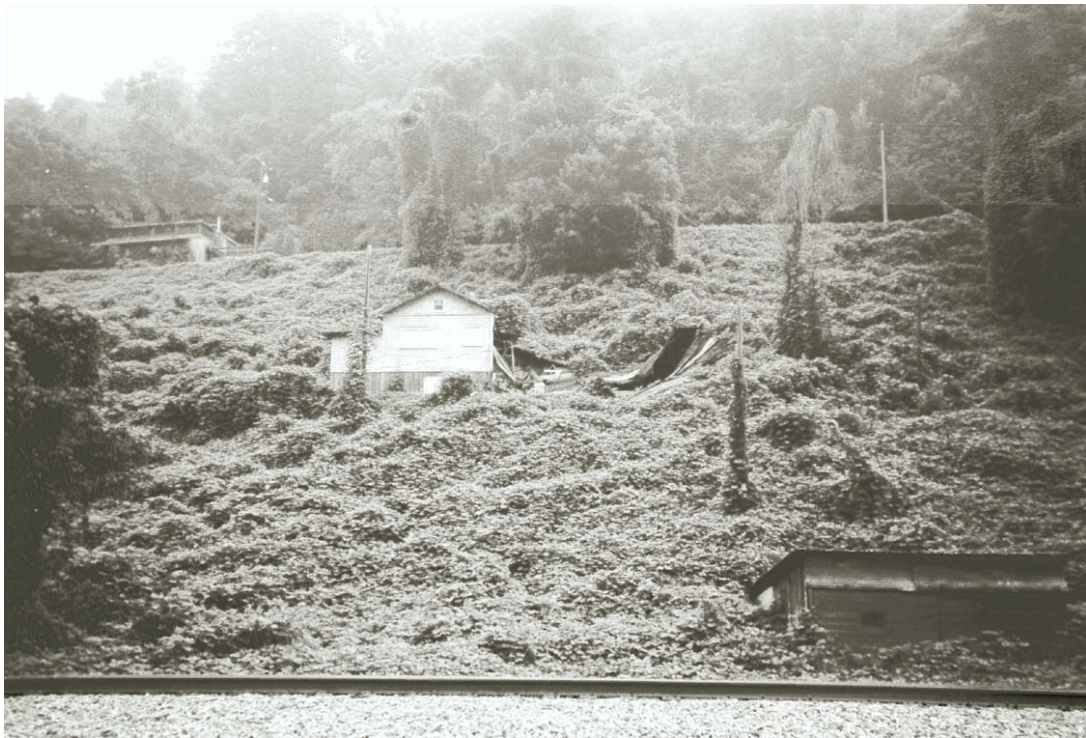
Extent of kudzu growth on the hillside near the Tom Kelly House, which collapsed in 2001 (PHSO 2002).

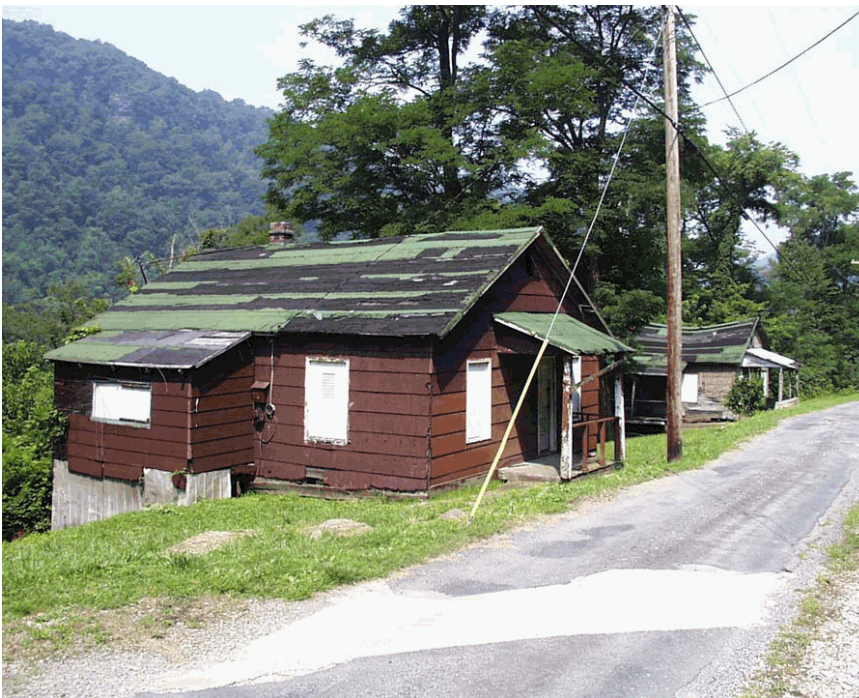
The Philip McClung Homeplace is a 1 story frame house that measures approximately 34' x 25' including the two shed additions. It has a covered porch that measures 10' x 5'. The gable roof is covered with rolled asphalt, and the house has been sided with asbestos shingles. The foundation is part concrete block and part wood pier.

The Philip McClung Rental is similar in construction to the adjacent Philip McClung Homeplace with the addition of a large projected addition centered on the northeast elevation. The house has a 1 story frame construction that measures approximately 28' x 32'. The house has both a stone and wood pier foundations and has some horizontal wood siding and bricktex tarpaper.

Phillip McClung Homeplace with Rental House in the background. Two of the remaining worker houses in Thurmond (PHSO 2002).

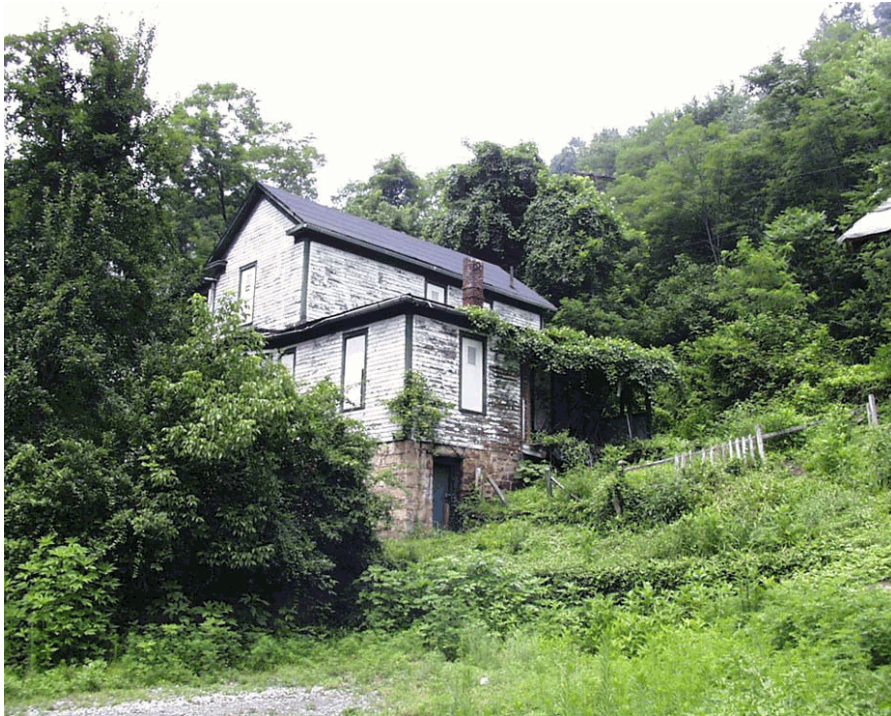
Fatty Lipcomb House with mortared retaining wall overgrown with vegetation. Note remnants of picket fence on right that are mentioned in Small Scale Features section (PHSO 2002).

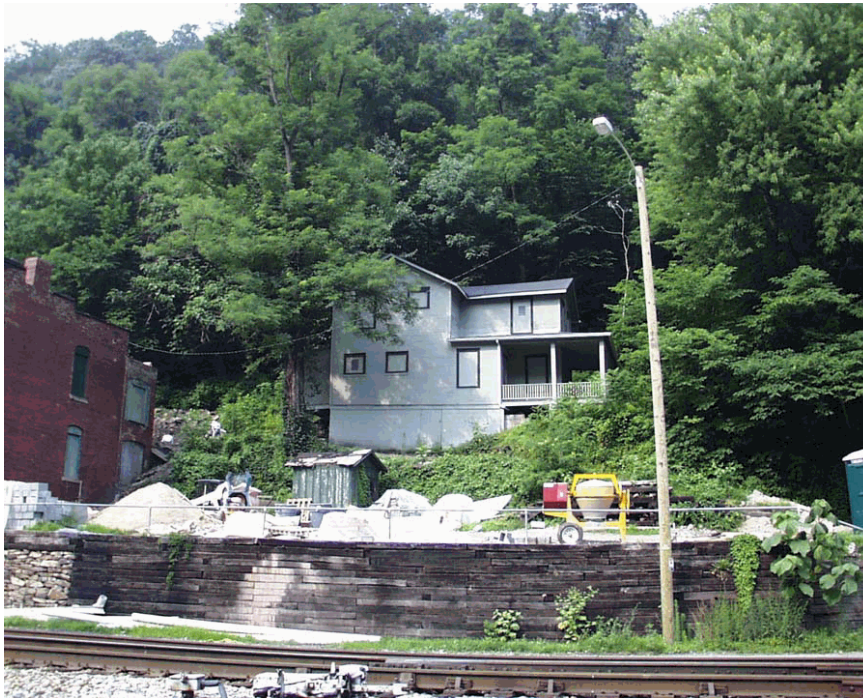
The house is supported by a long mortared stone retaining wall. There is a second retaining wall located further south from the house, but it has been broken up. The house was accessed by a set of steps leading up from the generally level area behind the commercial buildings. Closer inspection of the Erskin Pugh Rental House was not possible due to the thick growth of vegetation, specifically poison ivy.

Erskine Pugh House with commercial row retaining walls in the foreground (PHSO 2002).

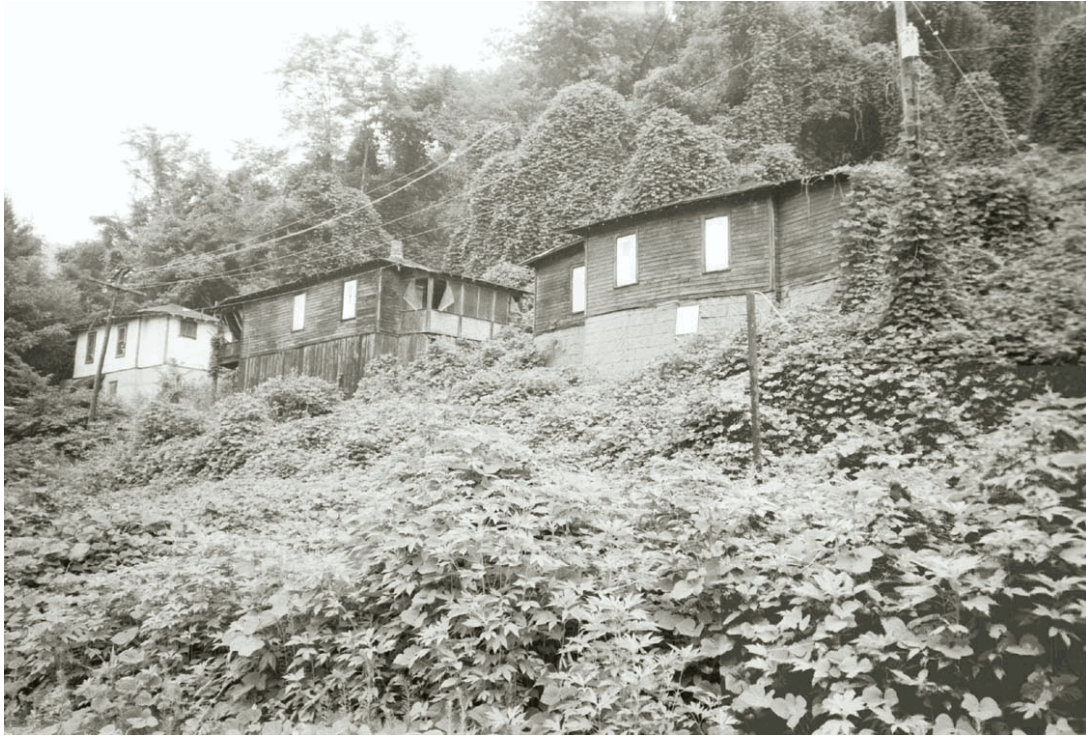
The Vivian Kelly House was inaccessible from the adjoining Drema Robertson House due to thick vegetation overgrowth, mainly kudzu. Therefore, the only access to the building was from wood steps leading up from the Sid Childers/Margie Richmond House. Built around 1920 (Harper 1983, 7:8) as worker housing, this 1 story, 4 room structure has a similar floorplan to the Drema Robertson and Margaret Dalton houses. The structure is host to multiple roof leaks and is being encroached on by kudzu. The porch to the north is mostly collapsed.

From left to right: Drema Robertson, Vivian Kelly, and Margaret Dalton houses (PHSO 2002).

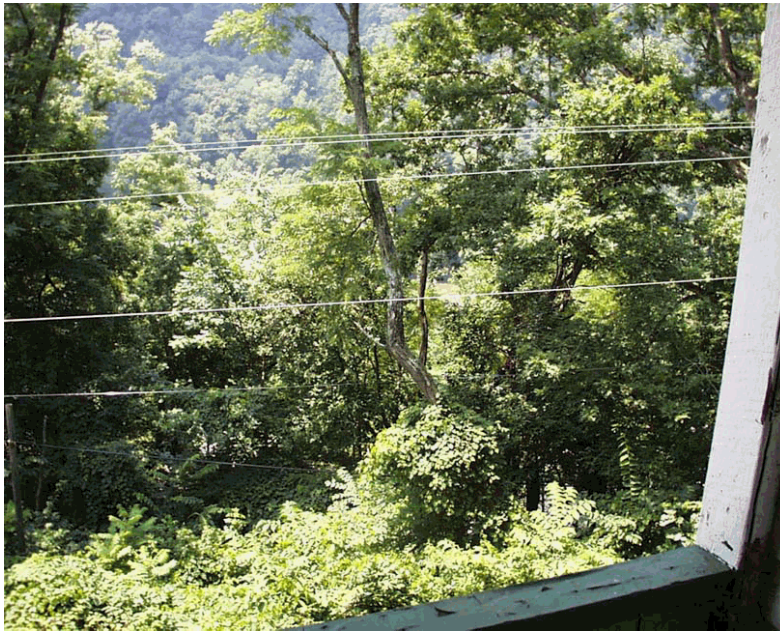
Typical historic view that is now blocked by uncontrolled vegetation growth, James Humphrey Sr. House (PHSO 2002).

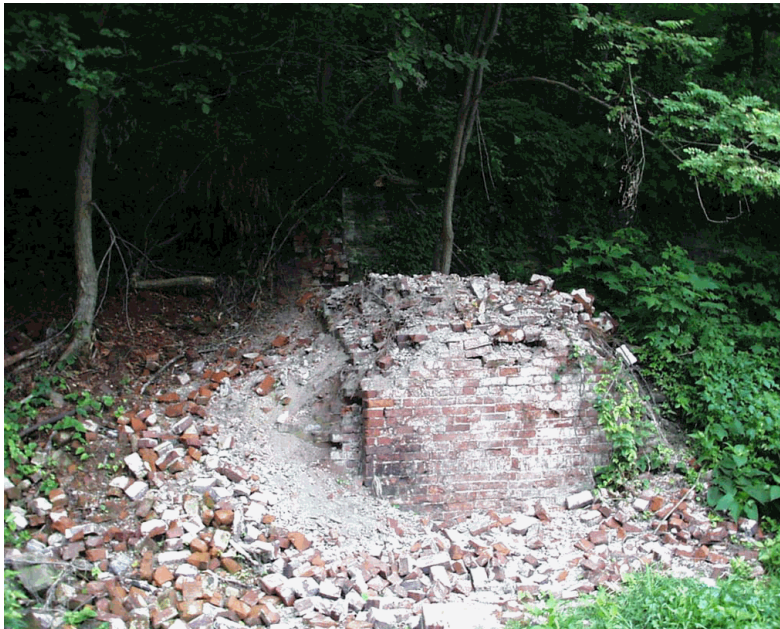
Lafayette Hotel remnants (PHSO 2002).
